Contribution of Resilience to the Analysis of Flight Crew Decision-Making: Example of a Near-CFIT in Public Transport

D. Delaitre, D. Nouvel, Y. Pouliquen, S. Travadel

BEA – Bureau d’Enquêtes et d’Analyses pour la sécurité de l’aviation civile
Statistics and Safety Analysis Division, Le Bourget, France
{didier.delaitre, david.nouvel, yann.pouliquen, sebastien.travadel}@bea-fr.org

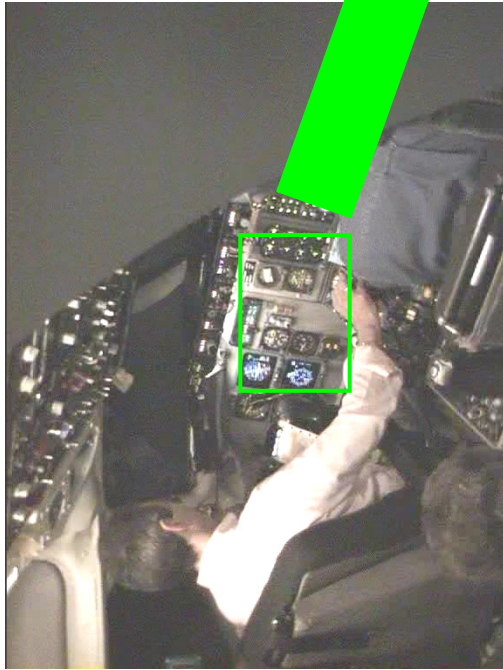
Fig. 1

During approach, the modes displayed on the FMA (figure 1) changed 30 times. The following description does not show all these modifications. Numbers 1 to 9 refer to the main steps of the approach as shown in figure 2.

The Captain probably connected the AP because he saw "LOC CAP" displayed on the FMA and thought he could still carry out the approach.

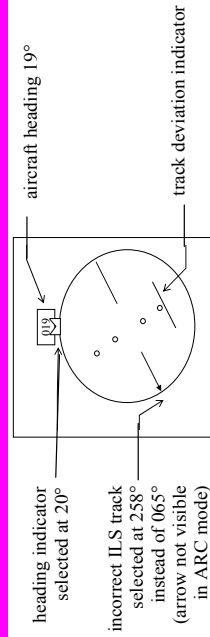
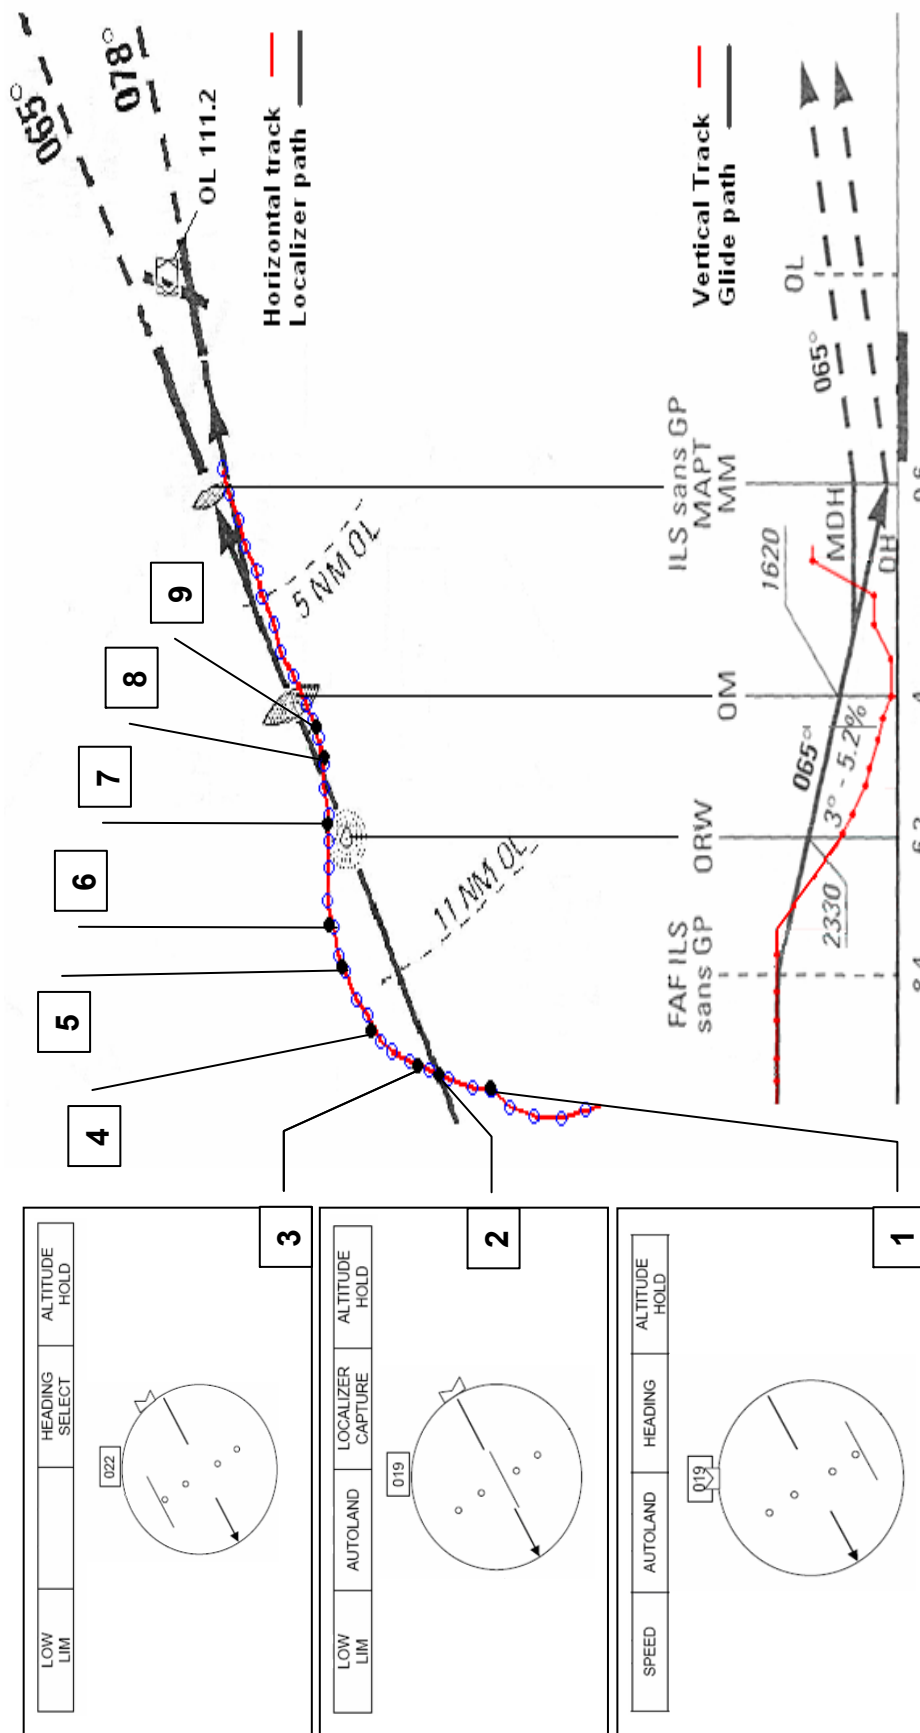
Fig. 2

The Captain then realized that he had selected an ILS heading of 258° instead of 065° and corrected it. Orly Tower indicated that the aircraft was 1.5 NM north of the track.

While the Captain was correcting the error and extending the flaps, the aircraft passed below the glideslope

At a radio-height of 916 feet, the GPWS "Glideslope" warning was recorded by the Quick Access Recorder (QAR) for 45 seconds.

At that moment, the radio-height was about 200 feet. At 12 h 32 min 09 s, the minimum radio-height of 67 feet and the Outer Marker signal were recorded. The co-pilot later stated that he saw the ground and read a radio-height of about 50 feet.
