Contribution of Resilience to the Analysis of Flight Crew Decision-Making: Example of a Near-CFIT in Public Transport

D. Delaitre, D. Nouvel, Y. Pouliquen, S. Travadel

BEA – Bureau d’Enquêtes et d’Analyses pour la sécurité de l’aviation civile
Statistics and Safety Analysis Division, Le Bourget, France
{didier.delaitre, david.nouvel, yann.pouliquen, sebastien.travadel}@bea-fr.org

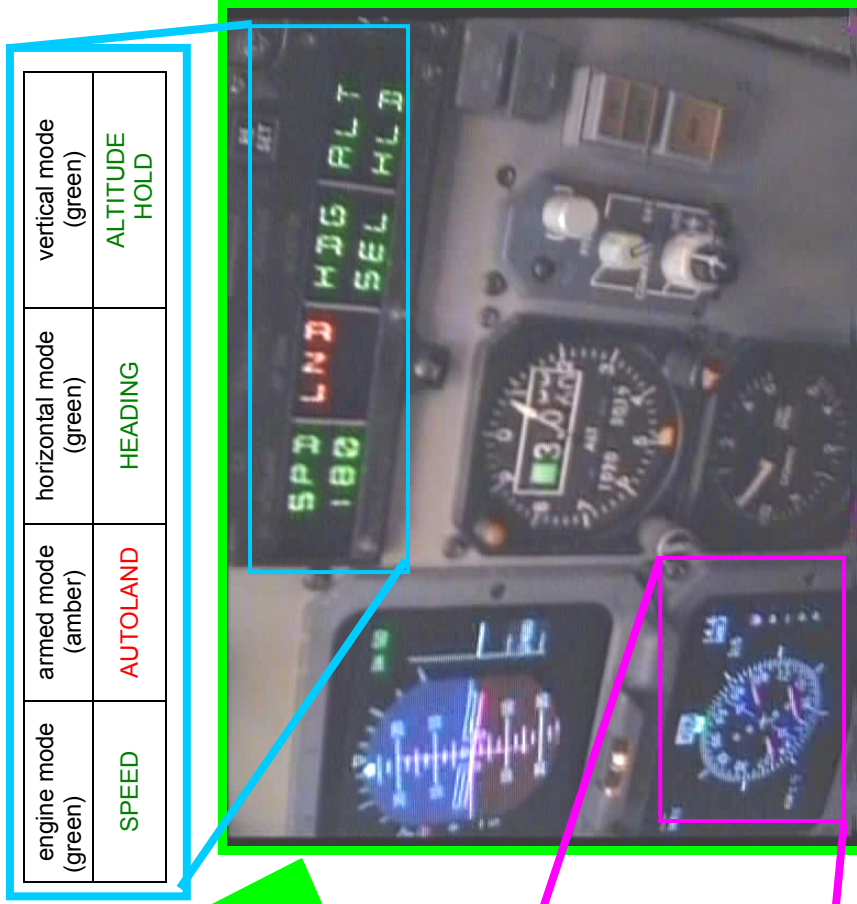
Fig. 1

During approach, the modes displayed on the FMA (figure 1) changed 30 times. The following description does not show all these modifications. Numbers 1 to 9 refer to the main steps of the approach as shown in figure 2.
